CENTRAL CONNECTICUT RAIL STUDY

INFRASTRUCTURE ASSESSMENT REPORT

CONNECTICUT DEPARTMENT OF TRANSPORTATION
STATE PROJECT NUMBER: 171-366

NOVEMBER 2014 - **DRAFT**

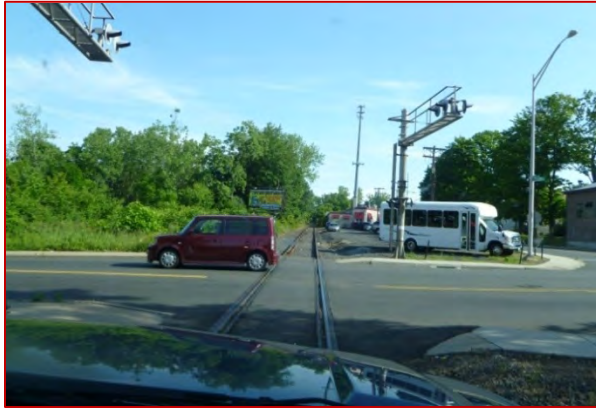
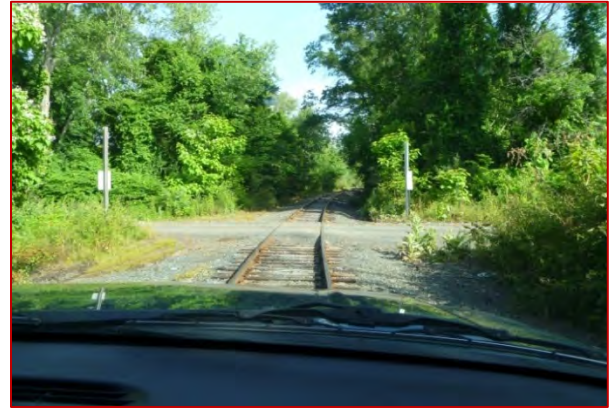
**Left: The approach to the South Street at-grade crossing, with only lights for advance warning.
Right: The approach to a private at-grade crossing, with only signs for advanced warning.**

For an upgrade to Class III track, it may not be necessary to upgrade the crossing equipment. However, because of the current timetable speed of 25 MPH, the approach circuits would need to be lengthened to accommodate the increased train speeds such that the warning systems are fully activated for the appropriate amount of time prior to the train arriving at the crossing.

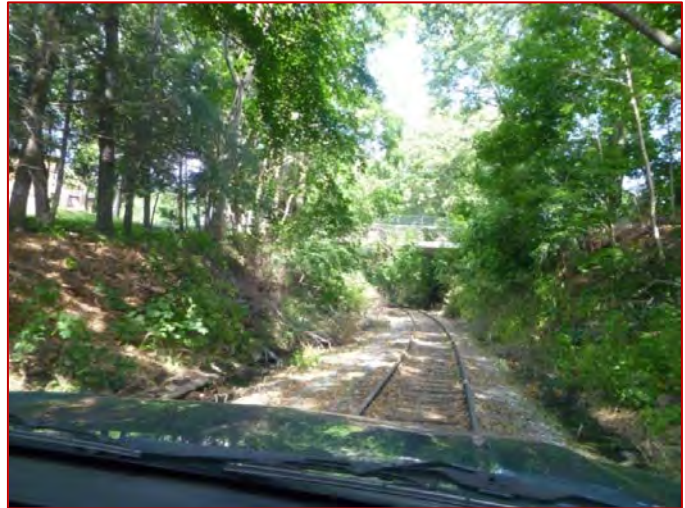
There are 50 culverts passing under the railroad right-of-way, and as expected, there are many rock cut areas with drainage swales running alongside the track. Several of these areas are obstructed by debris, silting and/or vegetation. This condition, if left uncontrolled, will contribute to the breakdown of the track structure.

Typical conditions in a rock cut area, including overgrown vegetation, obstructed drainage swales, and fouled ballast.

It is recommended that ditches and culverts be cleaned out and repaired as required as a part of the programmed upgrades to bring the Line up to Class II standards.

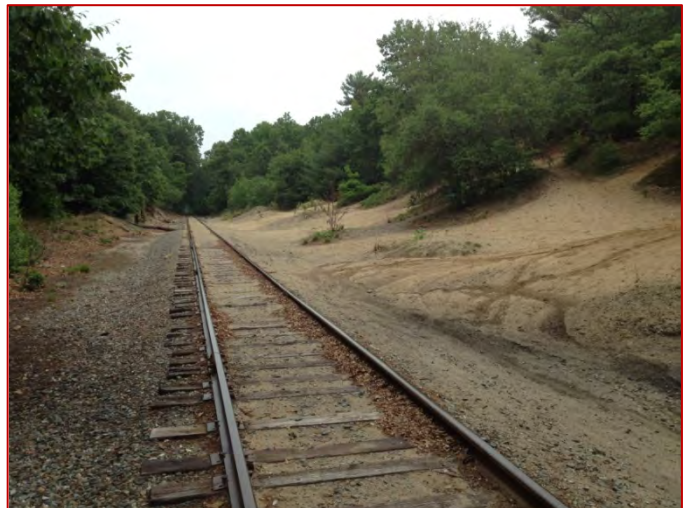
MP 13.5 - Area of Significant Fouled Ballast

In addition, of special note, was an area located at about Mile Post 13.5, between Route 6 and Farrell Avenue, in Bristol, was observed (see photo to the right). As can be seen in the photo, the track bed has significant infiltration of sand, which we were informed is due to trespassing off-road vehicles adjacent to the track. Due to the grade difference here, we suggest that some form of permanent barrier be installed to keep the material away from the track bed.

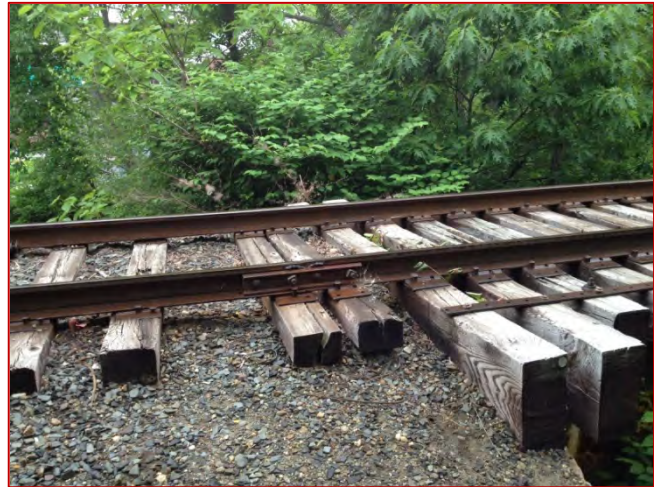
A large percentage of the wood ties on the line are considered to be in poor condition.

For a state of good repair, it is recommended that approximately 33% of the ties be replaced. During this improvement, the ballast should be cleaned and/or replaced, via undercutting or shoulder ballast replacement. There should then be a complete track surfacing and lining operation to restore the track to its design profile.

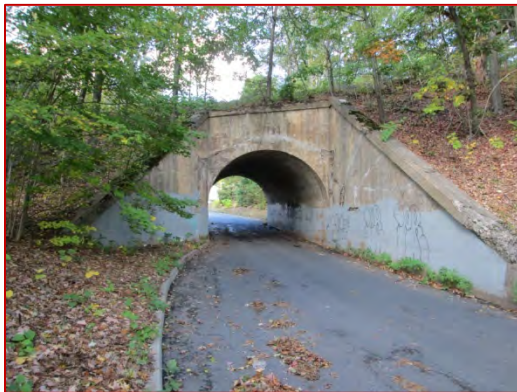
- D. **Stone Arches** – There are three stone arch bridges along the line. These structures typically have areas of missing mortar, deteriorated wingwalls, and debris at the inlet or outlet.
- E. **Concrete Arches** – There are ten concrete arches along the line. Most were constructed prior to 1910 and have areas of deterioration (cracks, scale, spalls and hollow areas) both on the underside and on the headwalls. A few have eroded/scaled areas along the waterline. Two examples are: 1) CCRS #14.4 over Barlow Street where the structure is in fairly condition, and 2) CCRS #15.3 over the Pequabuck River just east of the Terryville Tunnel where widespread cracking and a scour hole were noted.

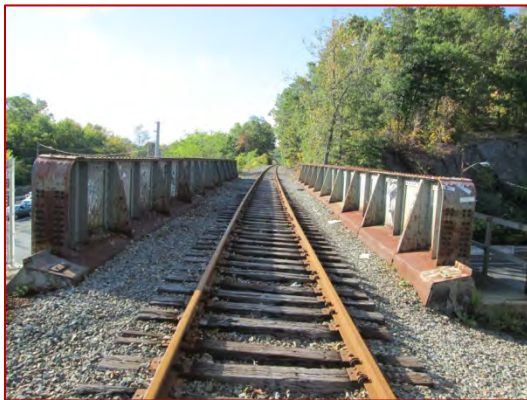
- H. **Steel Beam with Closed Deck** – There are six steel beam bridges with closed decks along the line. Five of the structures consist of beams supporting a deck with ballast supporting the rails and ties. These five are newer structures built for one track and are in generally good condition. CCRS #10.2 over King Street is typical of this type of structure. The sixth structure, CCRS #24.05 over Main Street in Waterbury, was built in 1906 and is a multi-track structure with through girders, an orthotropic steel deck and one active track. This structure is in poor condition with areas of significant deterioration noted on the deck, superstructure, and steel columns.

CCRS #10.2 over King Street
Typical steel structure with closed deck

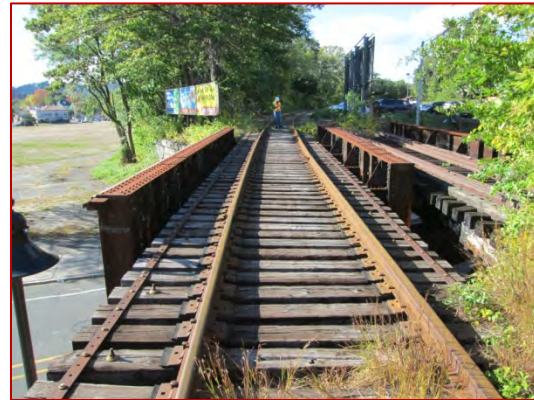
- I. **Steel Beam with Open Deck** – There are 21 steel beam bridges with open decks along the line supporting one track. These structures were installed in the 1910's and consist of longitudinal steel girders with the railroad ties fastened directly to the steel superstructure members. The structures typically have no remaining protective coatings and there are areas of corrosion with loss where debris accumulates and traps moisture. Most structures are in fair condition; however, some have components in poor condition due to corrosion and section loss. In many instances the abutments were constructed to support a superstructure for two parallel tracks, however, the superstructure for the second track may or may not be still in place. CCRS #11.3 over Main Street in Bristol is typical of this type of structure.

CCRS #11.3 over Main Street
Typical steel structure with open deck

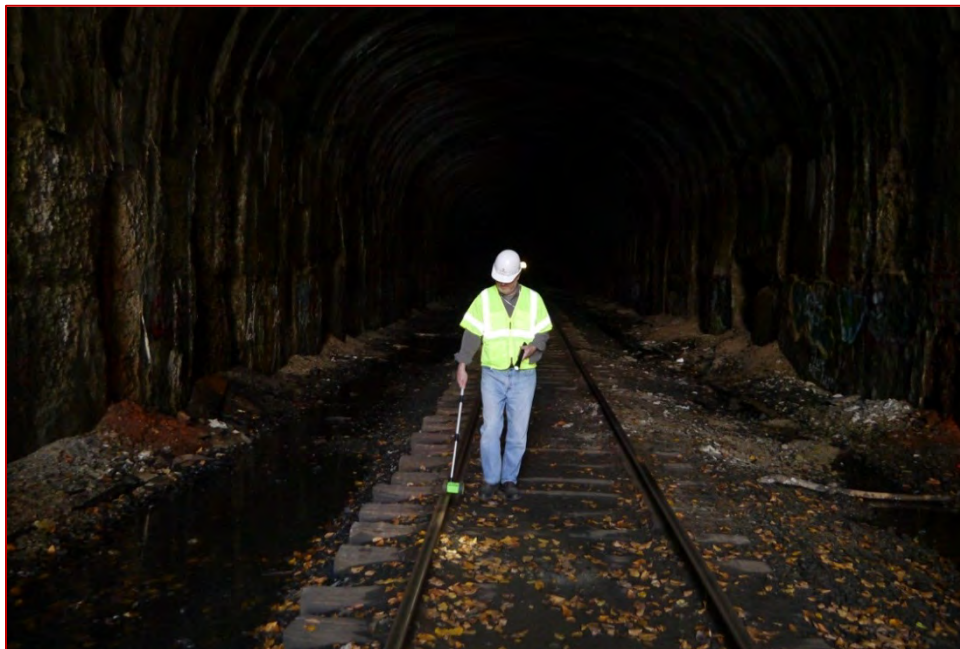
- As discussed above, a single track was relocated to the center of the tunnel in 1939. The area to either side of the track is filled with ballast and the invert of the tunnel was not observed during this inspection. Standing water in the ballast was observed on the northern and southern sides of the tunnel from approximately 50' inside the tunnel to the eastern tunnel portal. Otherwise the ballast was superficially dry. In areas of degraded tunnel lining, material that has fallen off the walls has been allowed to accumulate on the tunnel invert. This appears to have been allowed to accumulate for many years (See Figure 12).

**Figure 12: Current Single Track and Water around Invert
(also note accumulation of debris at toe of sidewalls)**

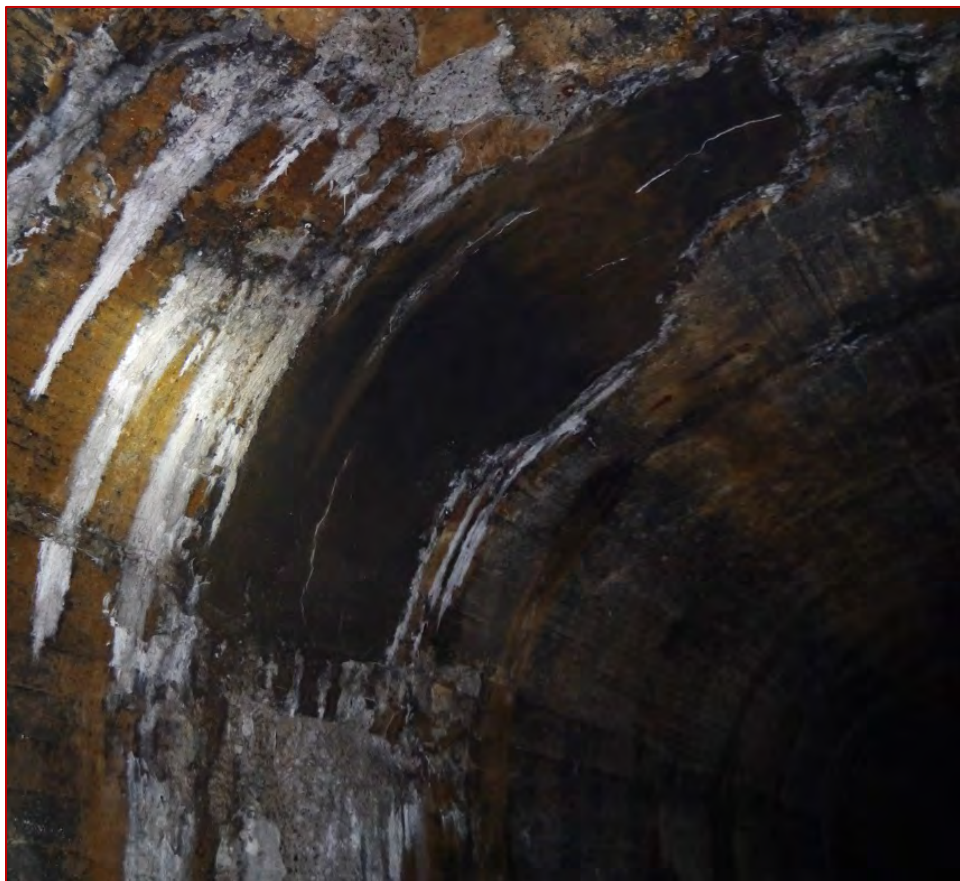
- At some point in the past a significant amount of remedial work appears to have been undertaken in the more degraded sections of tunnel lining. Steel mesh and concrete has been used to patch degraded areas of the original lining. No record is available of when this work was completed but based on observations it is likely to be a long period in the past. In a number of areas these remedial patches have subsequently failed, largely due to groundwater issues, as described below (see Figure 13).

**Figure 13: Past Repair Work to Tunnel Crown
(date of work unknown)**

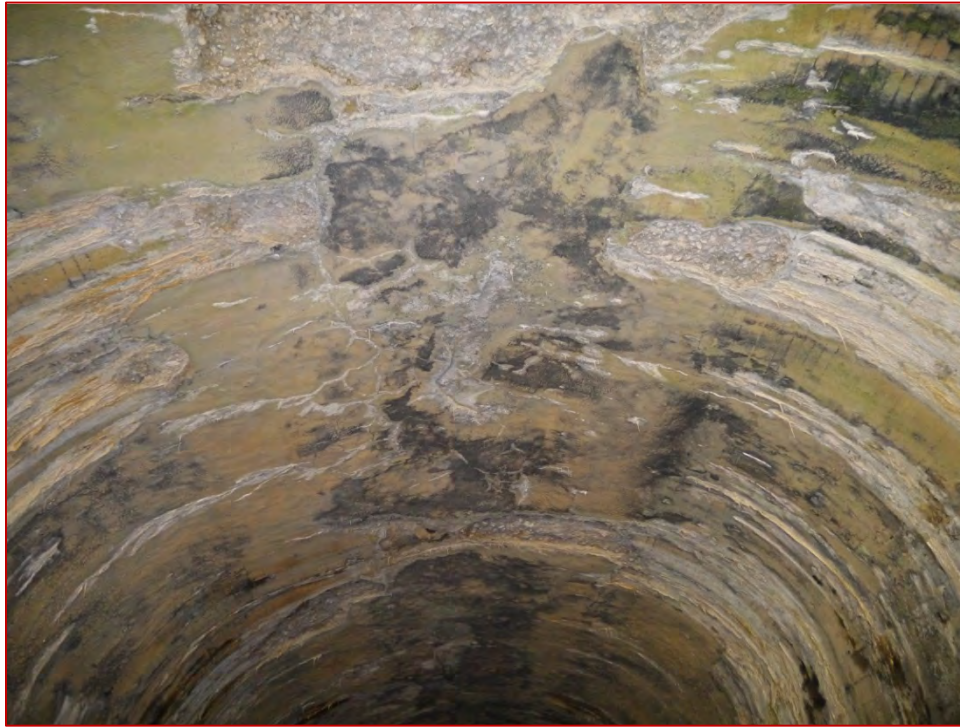
Figure 14: Tunnel Crown

This category of tunnel was observed between Station 24+00 and 26+00 and 29+00 to 33+00. Other small sections were observed. For preliminary estimation purposes this category is estimated to represent 20% of the tunnel length. Figure 14 shows an example of the tunnel crown in one of these sections.

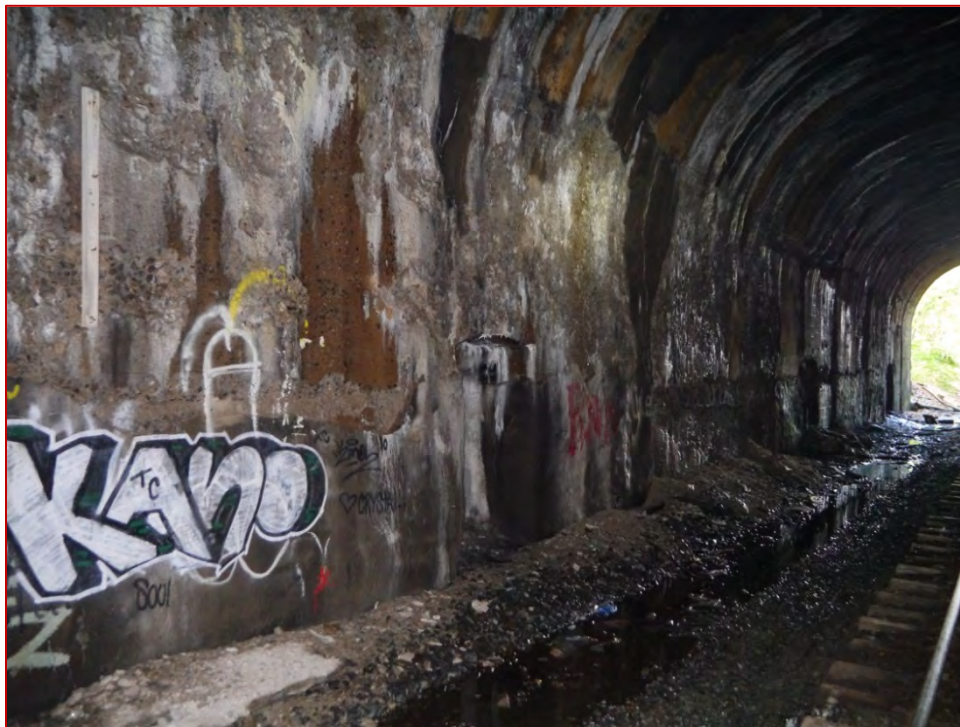
In these sections of tunnel the original lining, and often the later remedial lining works, are typically extensively degraded. The concrete lining is characterized by extensive areas of minor to severe scaling (up to 80% of tunnel surface – Figure 15). Furthermore, in localized areas (approximately 5% of tunnel area) the concrete lining has failed completely exposing the underlying rock mass or rock mass with a veneer of residual concrete (individual areas up to 30 square feet) – Figure 16. These failures occur most frequently towards the base of the sidewalls or in the back wall of the safe retreat alcoves where the concrete thickness is significantly less (approximately 3”) – Figure 17. However, they can also occur in the crown. In addition, in some of these failed areas the concrete has lost integrity, being reduced to a dense sand/gravel mix that can be excavated by a geological hammer – Figure 18. In all these areas reinforcing is frequently exposed and is either severely rusted or lost completely – Figure 19.

Figure 15: Extensive Scaling from Walls at Eastern Portal

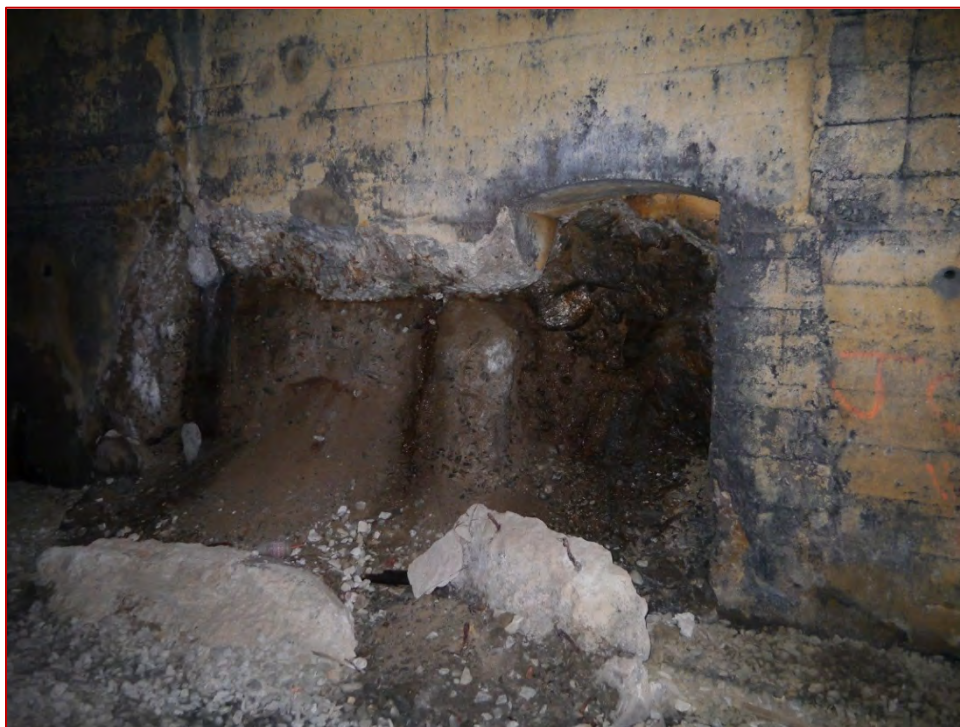
Figure 16: Local Failure of Concrete Lining and Exposure of Rock

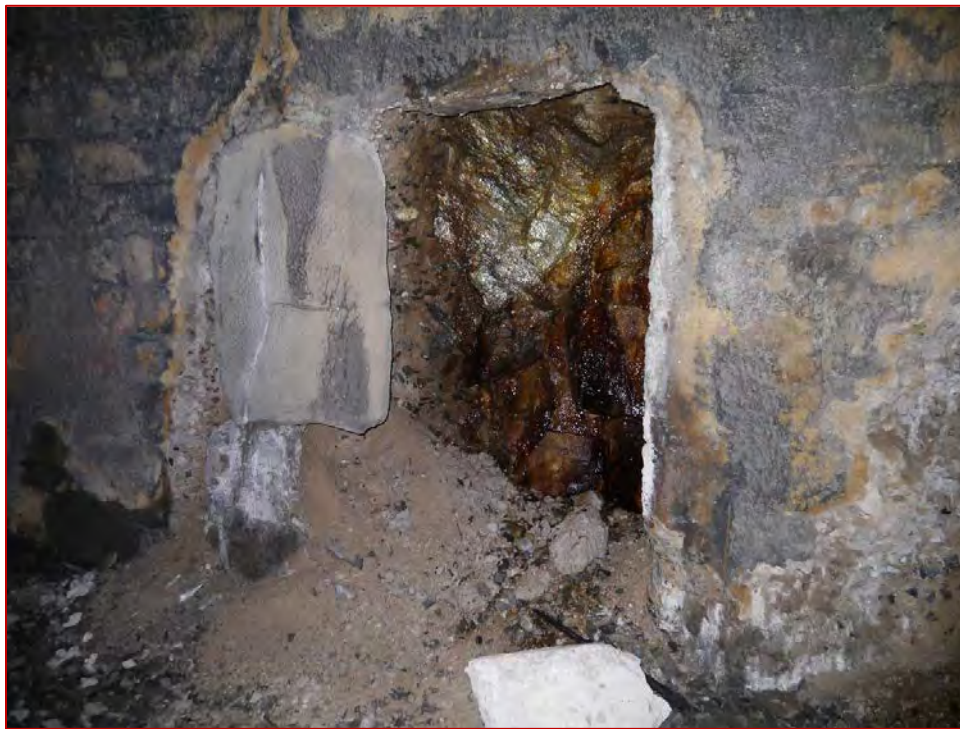
**Figure 17: Failure of Alcove Lining Exposing Rock Mass
(note flowing groundwater)**

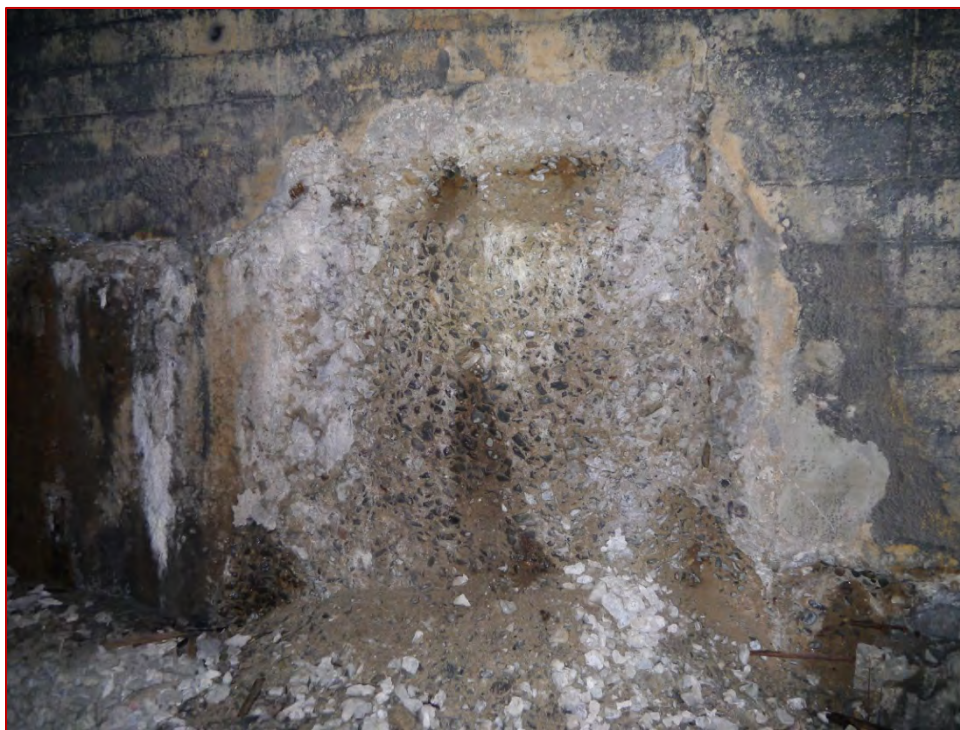
Figure 18: Concrete Reduced to a Dense Sand/Gravel Mix

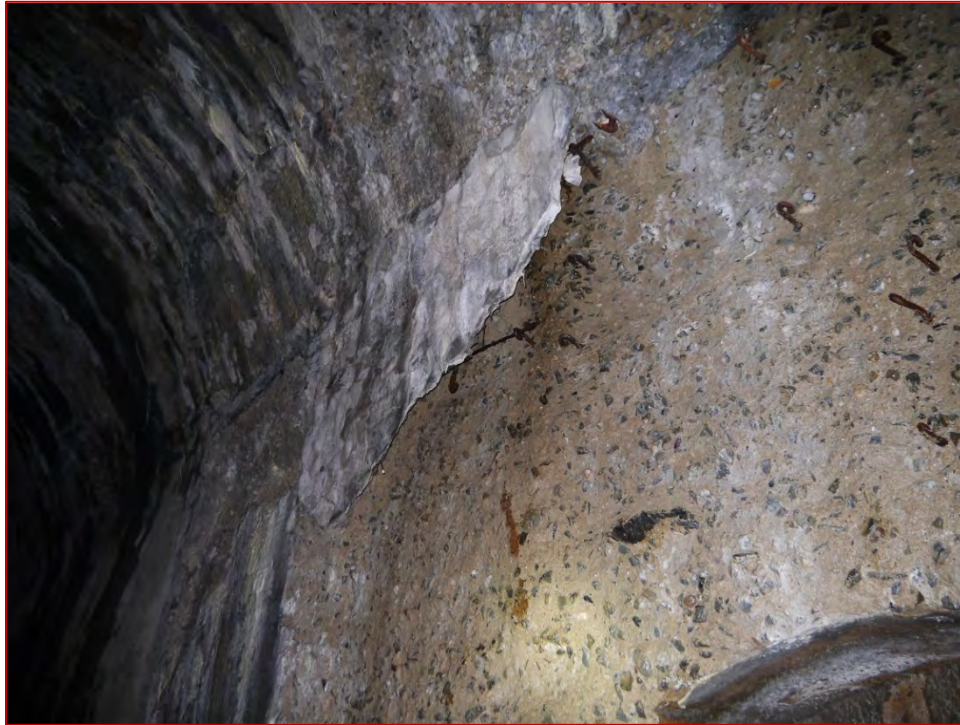
Figure 19: Exposed and Rusted Reinforcing

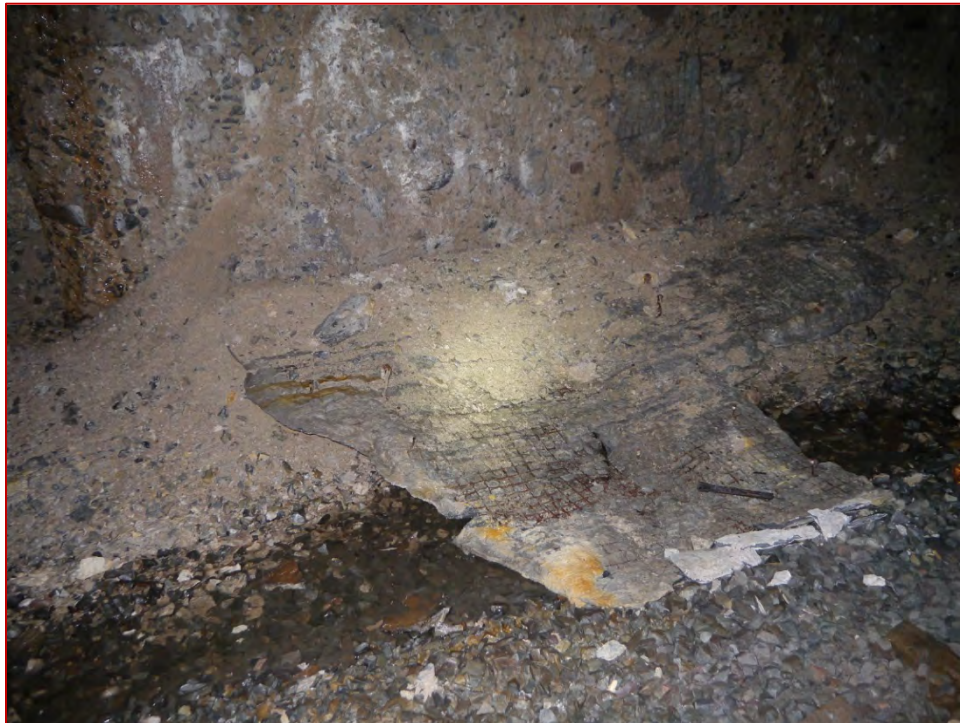
Cracking is extensive (spacing less than 10’) and minor to severe. Staining is also extensive (greater than 90% of tunnel surface) and efflorescence is common (50 to 70% of tunnel surface). As discussed above, old remedial works were focused in these areas and have now also frequently degraded or failed (Figure 20).

Figure 20: Failed Remedial Works – Steel Mesh/Concrete
