CENTRAL CONNECTICUT RAIL STUDY

INFRASTRUCTURE ASSESSMENT REPORT

CONNECTICUT DEPARTMENT OF TRANSPORTATION
STATE PROJECT NUMBER: 171-366

NOVEMBER 2014 - **DRAFT**

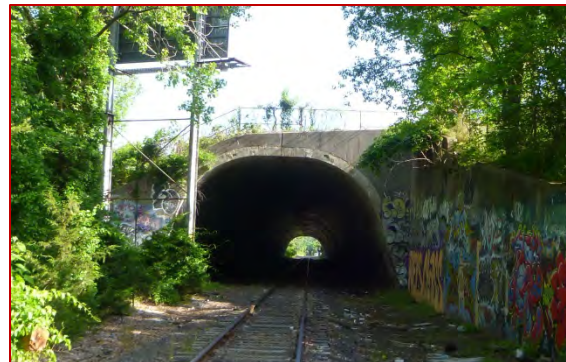
CCR #1.0 Tunnel under Route 9

- A. **Overhead Structures** – There are 20 overhead structures along the line which are owned and maintained by others. No evaluation of these structures was made.
- B. **Tunnels** – There are three tunnels along the line. Two of these are concrete arches constructed in the 1970's to support Route 9/72. These tunnels are in good condition and rehabilitation is not required at this time. The third tunnel is the 3,580 foot long Terryville Tunnel constructed in 1910. The condition of this structure and the required repairs is discussed separately in Section 5 of this report.

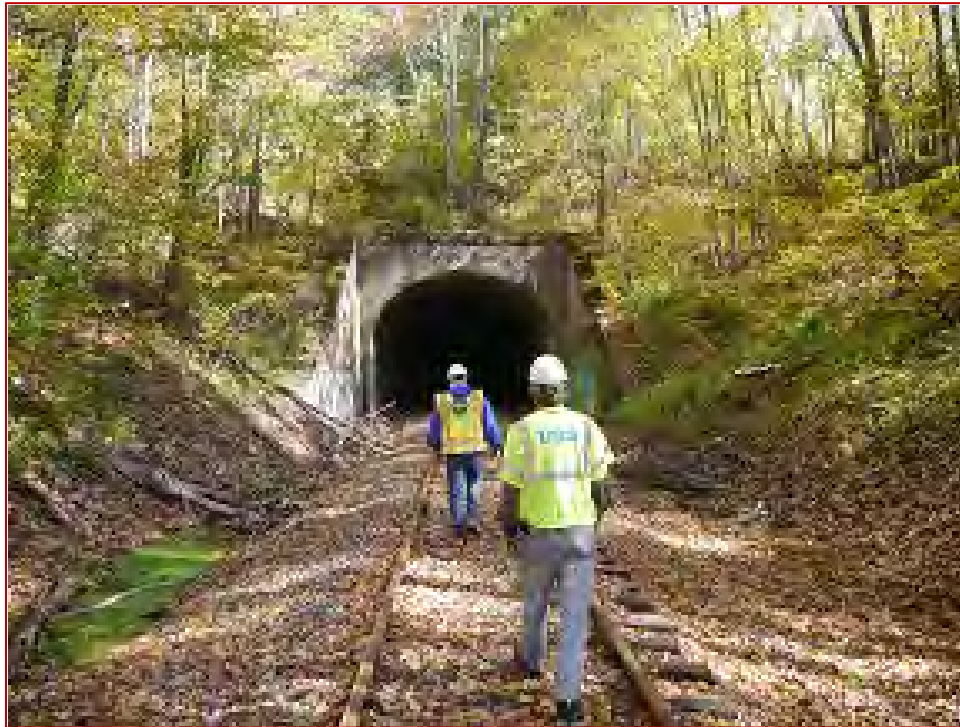
Figure 7: Western Entrance to the Terryville Tunnel

The tunnel is 3,580 feet long, horseshoe shaped with a reported height of 24' and width of 36'⁸ (Figure 7). At this time it has not been possible to locate the original design or construction records for the project. The information currently available includes: a series of historical photographs; contemporary newspaper articles; and the geological map for the area.
